# Photographs and Visual References

Listed Building Consent | St Benedict's Church, Ardwick

| APPLICANT | BUILDING | PURPOSE | ISSUE |
|---|---|---|---|
| Manchester Vineyard | Grade II* listed | LBC supporting document | P03 August 2026 |

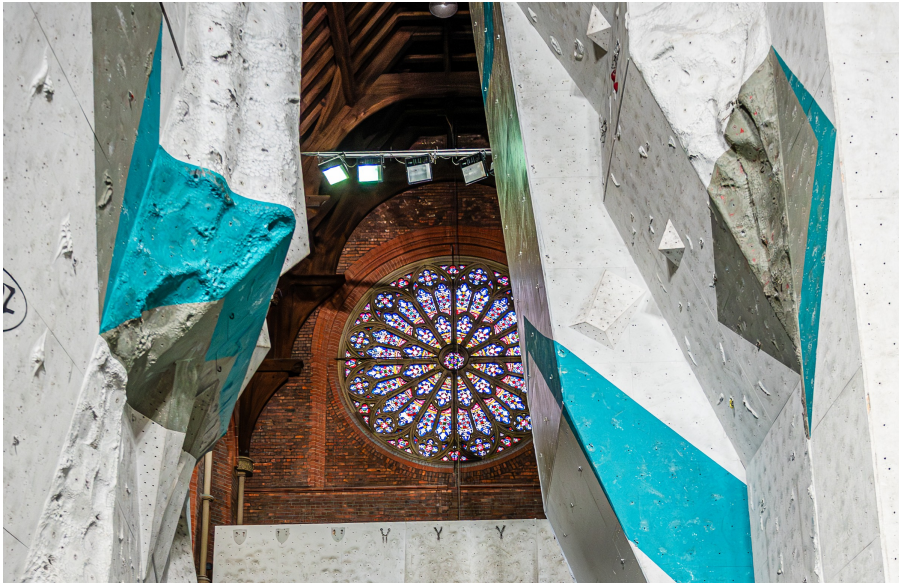
**P03** Nave looking west toward the rose window. The climbing walls and later cladding interrupt the west-end relationship and conceal the entrance arrangement below.

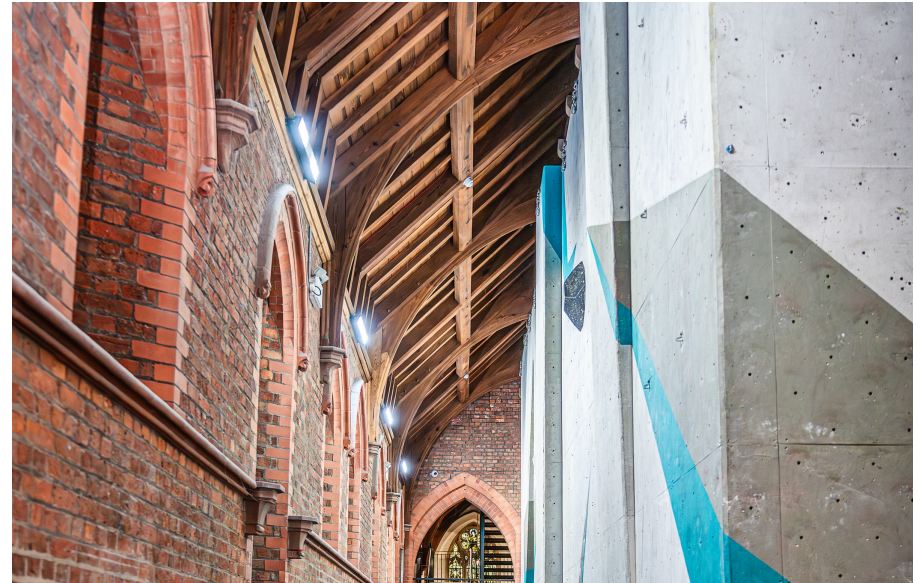
**P04** North Aisle looking west. The retained brick wall, roof and floor remain legible beside the climbing structure; the new level doorway is formed farther east as detailed by BTP.

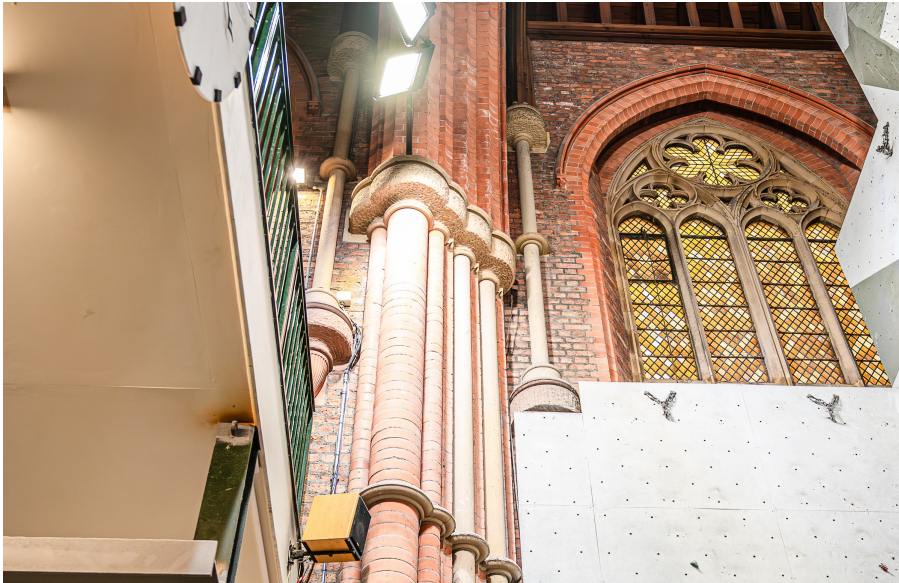
**P05** Climbing wall immediately beside historic brick arcading, stone dressings and roof structure. Protection and controlled removal are required throughout.

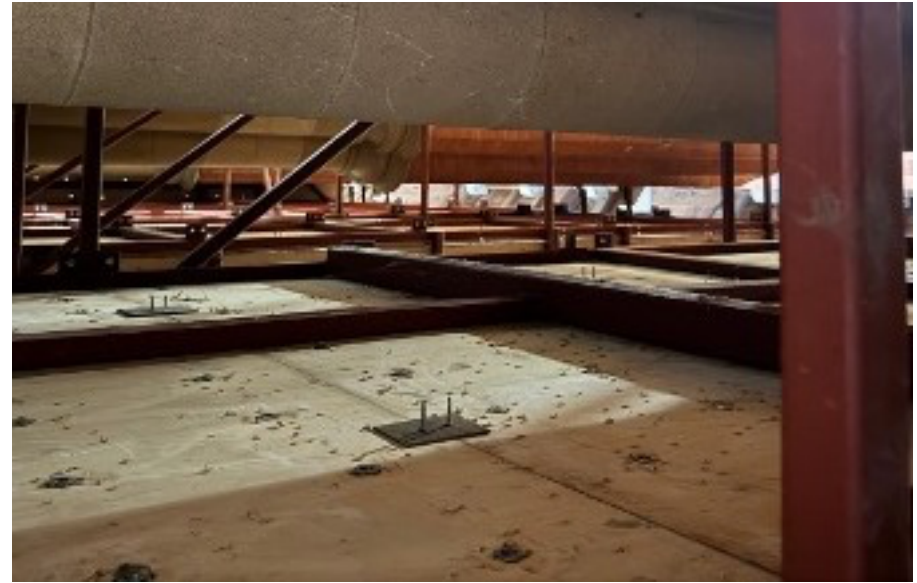
**P06** Reverse face of the climbing installation beside a historic arcade column, showing the red-painted steel sub-frame, plywood backing, protruding bolts and connection components. The frame is to be dismantled without levering or bearing against the column.

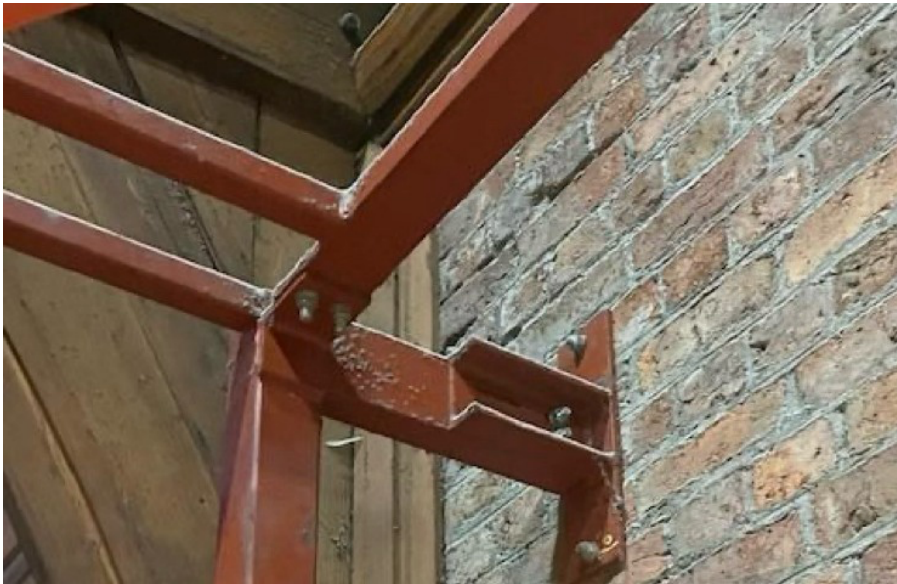
**P06a** Steel wall bracket and supporting frame fixed directly into historic brick masonry beside a timber opening. Remove the bolts without twisting or levering the bracket against the brick face.

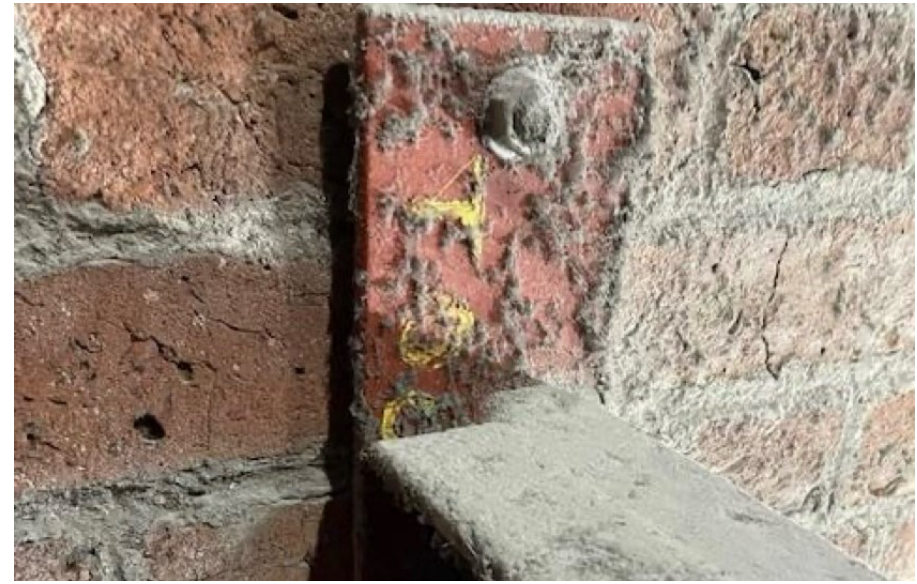
**P06b** Close view of a steel member, end plate and fixing into historic brickwork. The fixing position, hole and adjacent mortar joints are to be recorded before compatible repair is agreed.

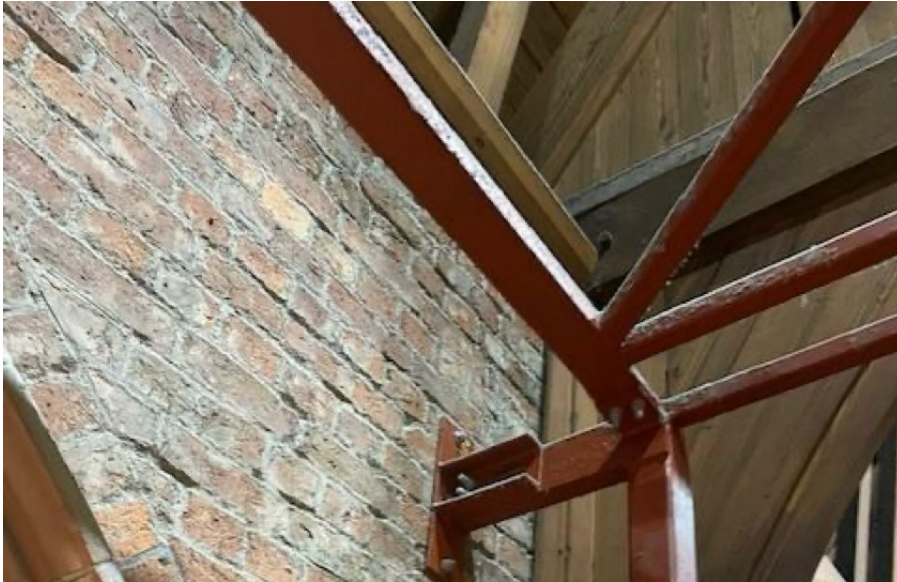
**P06c** Red-painted steel sub-frame and bracket fixed against historic brick masonry beside an architectural opening. Adjacent brickwork, timber and dressings are to be protected throughout removal.

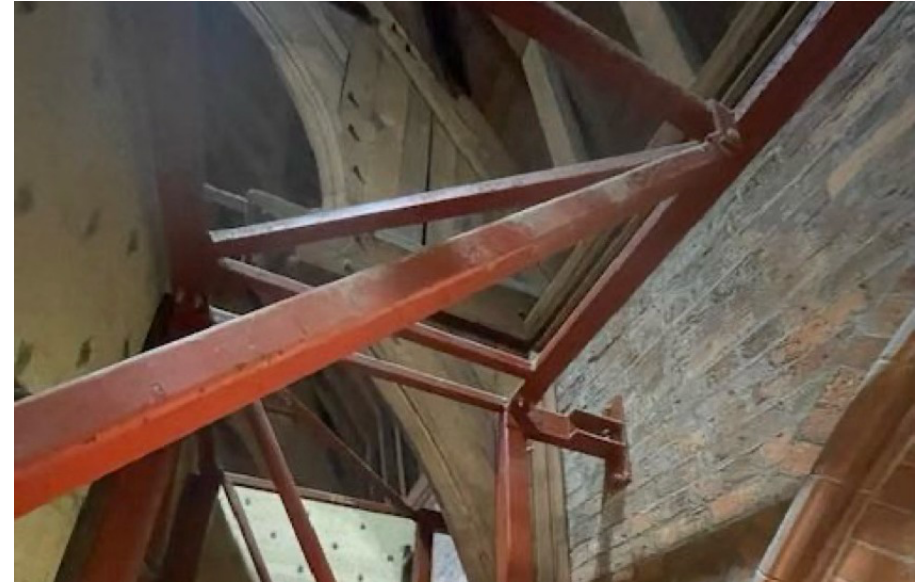
**P06d** Wider view of the climbing-wall steel frame alongside historic brickwork and opening details. Members are to be supported and lowered in manageable sections after the wall fixings are released.

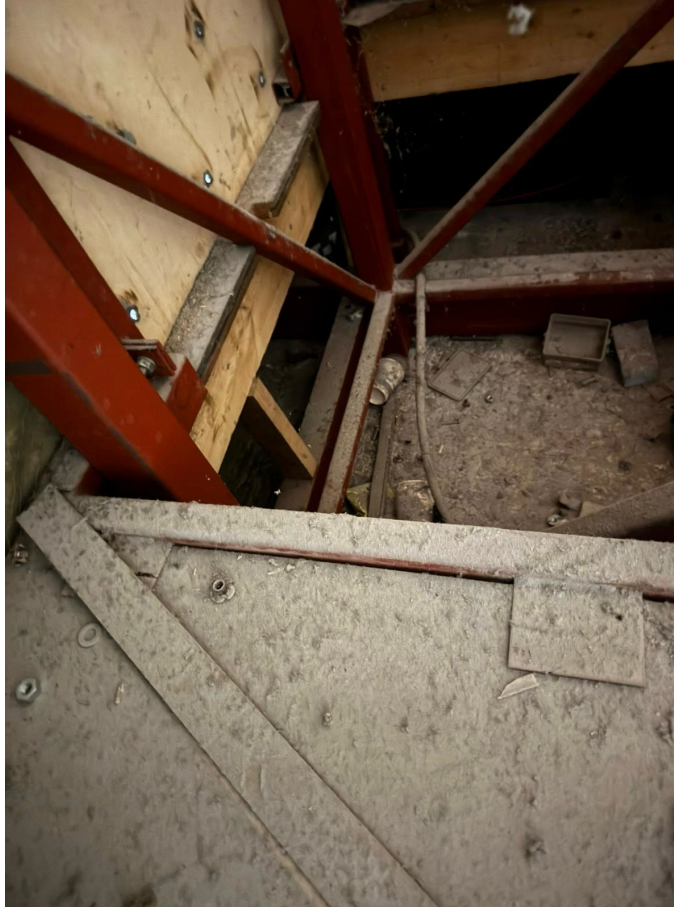
**P06e** Floor-level climbing-wall framework and panel backing, including bolted steel members and loose components. Protect the retained floor, control debris and record the exposed substrate before making good. *Source: Manchester Vineyard inspection photograph. Drawing reference: 110, 111 and 120.*

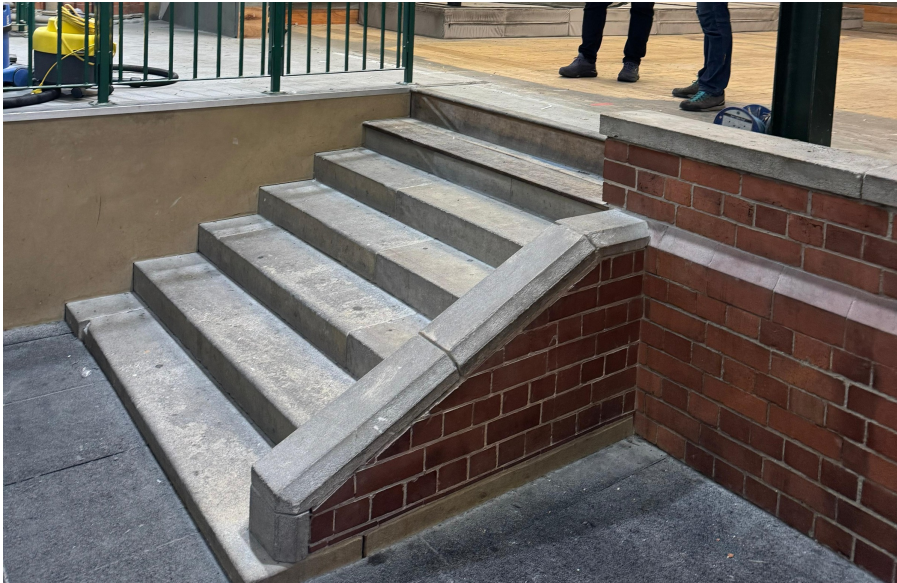
**P07** Chancel steps, later low brick wall and coping. Only the approved approximately 1000 mm section at the south side is to be dismantled for the platform-lift connection.

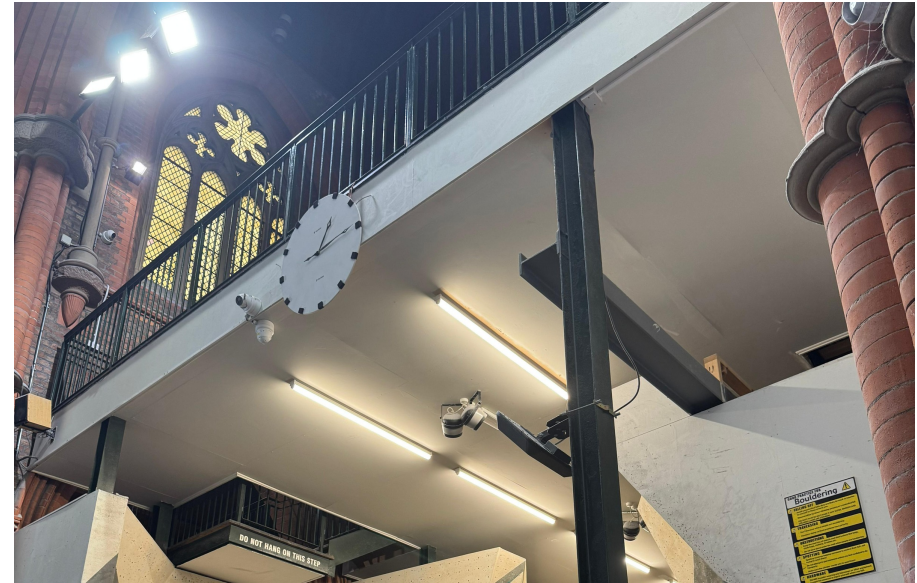
**P08** Retained Chancel mezzanine with later bouldering walls and enclosure below. The climbing elements are removed to reveal and reuse the underlying Chancel space.

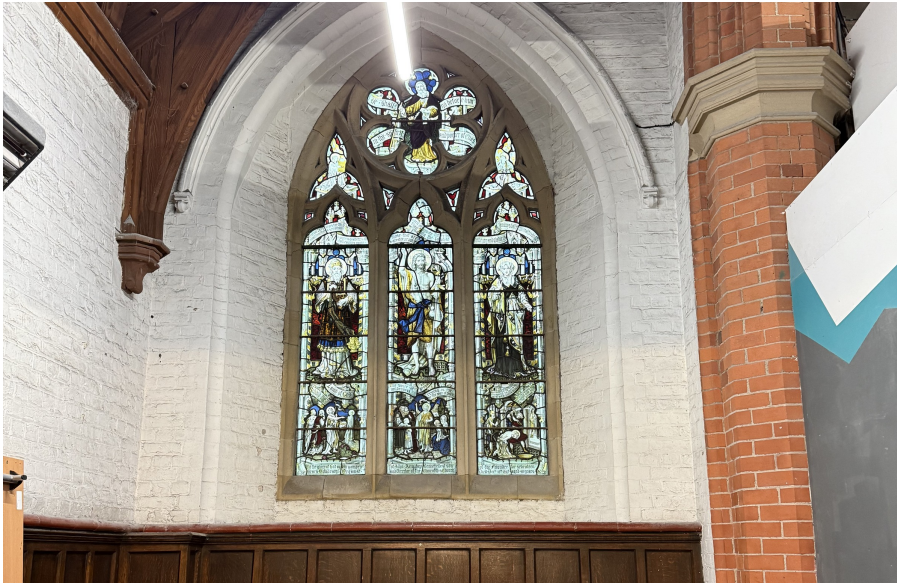
**P09** Historic timber panelling and stained-glass window in a Chancel side area. New linings and kitchenette work are to remain independent and protect these features.

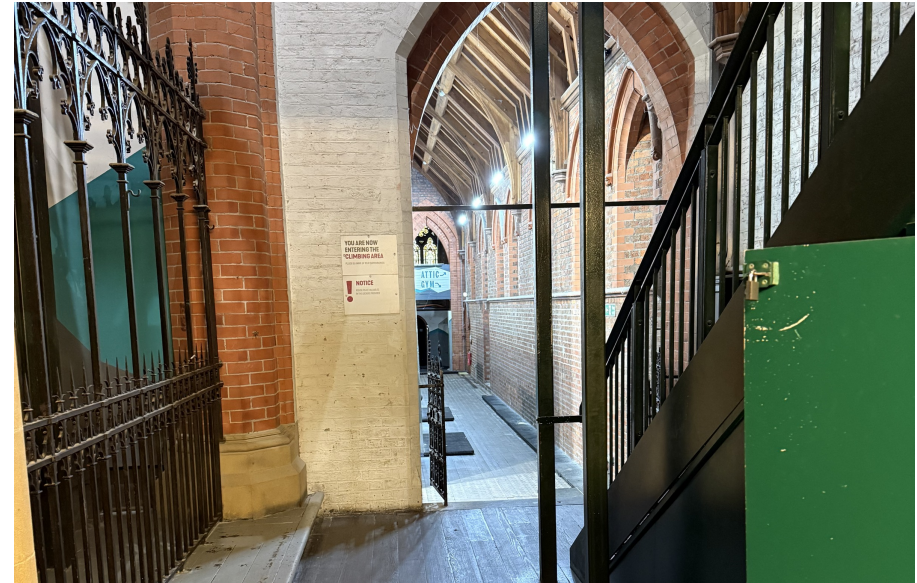
**P10** Historic parclose screen, aisle and adjacent later steel enclosure. The screen is retained and the paired gates are retrieved and refixed where shown.

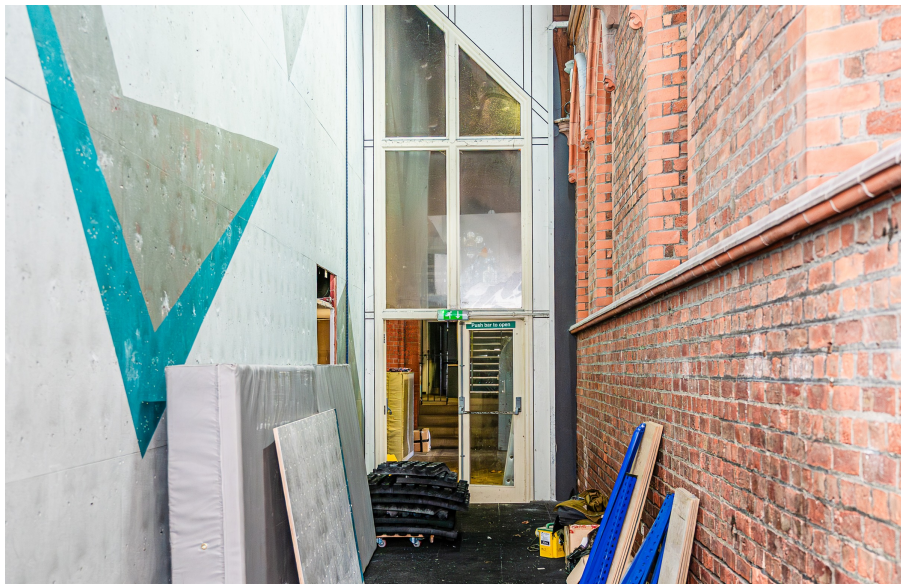
**P11** Existing later partition within the aisle circulation zone. The climbing-centre enclosure is removed or altered as shown to restore clearer circulation and views.

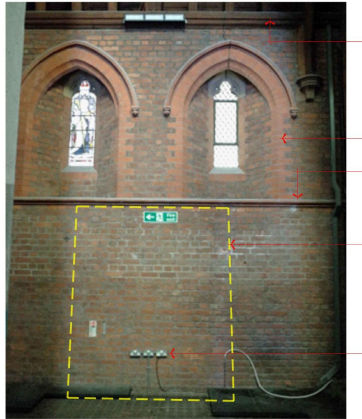
Proposed Location (not to scale)

**V03** Annotated existing photograph identifying the approved North Aisle opening with a yellow dashed outline and the services to be relocated.
