# METHOD STATEMENT, PRESERVATION AND DISPOSAL PLAN

**ST BENEDICT'S CHURCH, BENNETT STREET, ARDWICK, MANCHESTER**

Grade II\* listed building | NHLE 1207939

Manchester Vineyard | Issue P01 | 10 August 2026

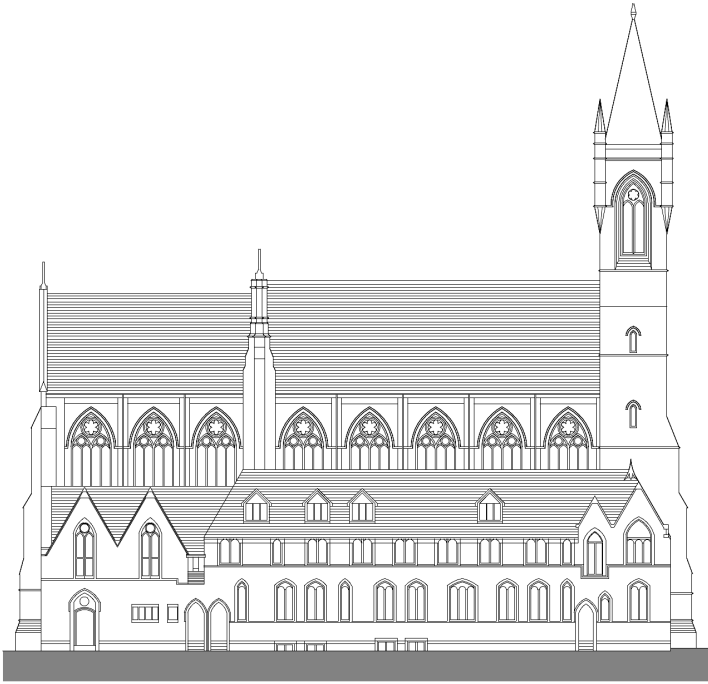
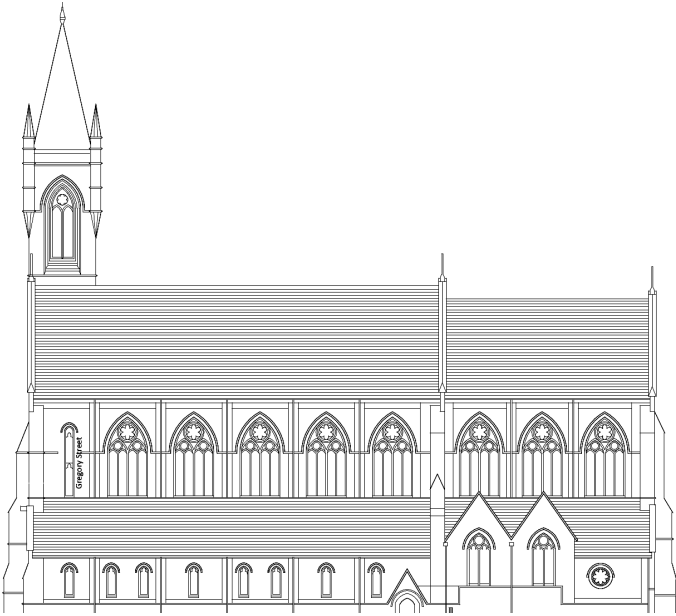
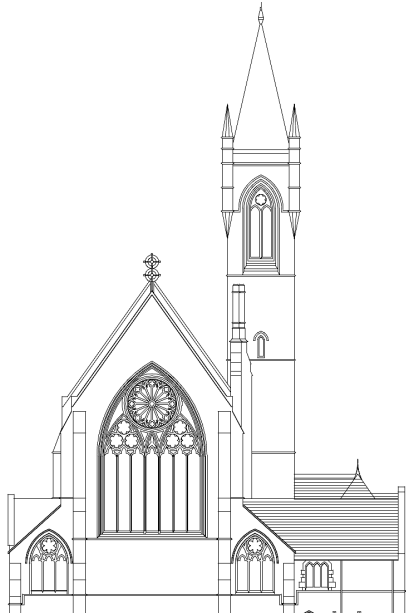
Figure 1 — Existing North and South elevations of St Benedict's Church

Figure 1 illustrates the existing principal elevations and should be read with BTP drawing A-105.

North Elevation as Existing  
1 : 200

East Elevation as Existing  
1 : 200
